# INTERIM REPORT

## Bicarbonate of Soda Stripping Evaluation

AUTHOR  
SMSgt Mark A. Foley  
Air Force Corrosion Prevention and Control Office  
AFRL/MLS-OLR  
325 2<sup>nd</sup> Street  
Robins AFB GA 31098-1639

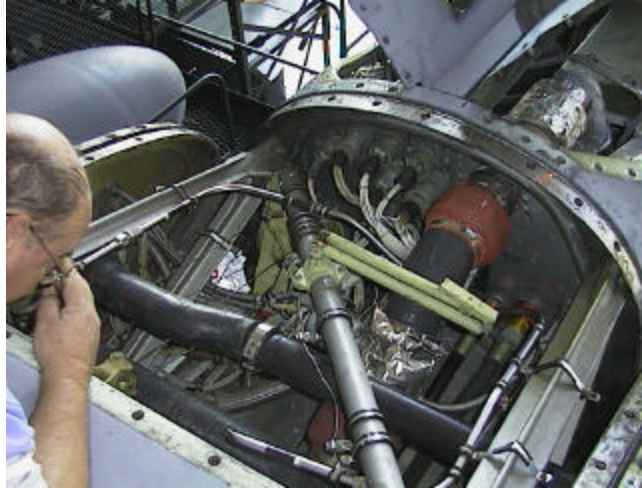
- Primer removed to bare metal on the L/E spar and vertical Webb, in the "horse collar" area. (C-130 acft. all engines) NOTE. The primer had been removed/damaged by previous depaintings using chemical paint removers.

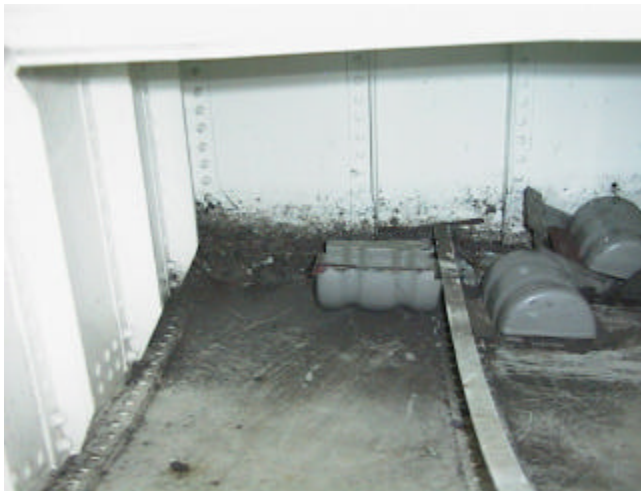
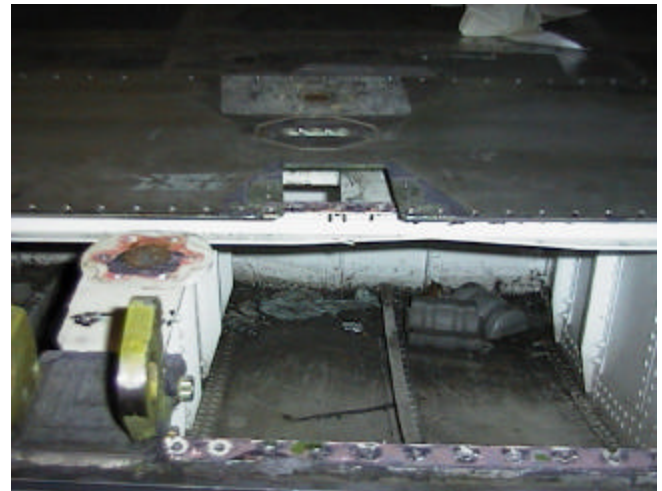
- Under flow area (Bilge), of the C-141 aircraft was contaminated, (severely) with dirt, hydraulic fluid, and other unknown substances. When we asked a maintenance specialist, "How often is the under floor area on the C-141 cleaned". His reply, "Since refurbishment is no longer accomplished as a special inspection, except for a single floor panel adjacent to the forward lavatory (rt. fwd), and the aft center panel, none of the floor panels are removed unless a major spill occurs in the cargo compartment". (NOTE) No

evidence of soda was detected in the "bilge" area.

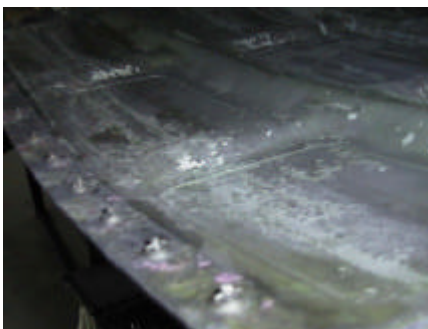
- Numerous areas in the wing-to fuselage attach area on the C-130 and C-141 had been contaminated with pant remover from previous depaint operations. The paint remover had removed the primer and the bare metal surfaces were not adequately protected from corrosion. Several areas showed signs of dried paint remover. Again, no evidence of soda residue.

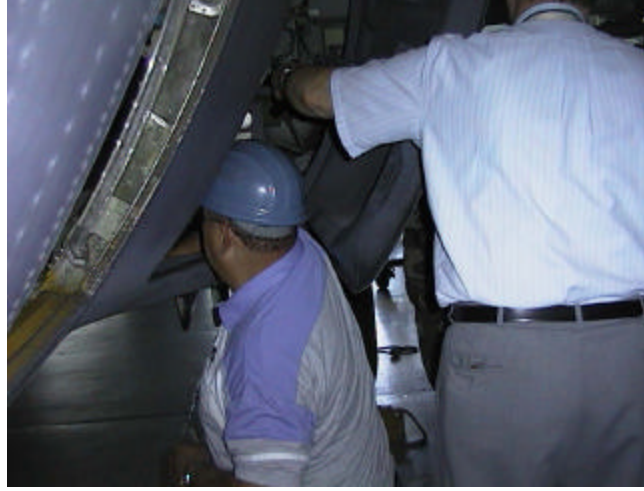
- Minor liquid paint remover residue and contamination from routine operations was detected in the forward and aft interior areas of the main landing gear pods on the C-130 and C-141 aircraft as well as the air deflector wells on the C-130. Again no residue.
